Project – Phase 2 Knockrabo Development, Mount Annville Road, Goatstown, Dublin 14.

An Arboricultural Assessment of the Tree Vegetation on the Site Area for 'Phase 2' of the Knockrabo Development, Mount Annville Road, Goatstown, Dublin 14.

Date: 26th October 2021

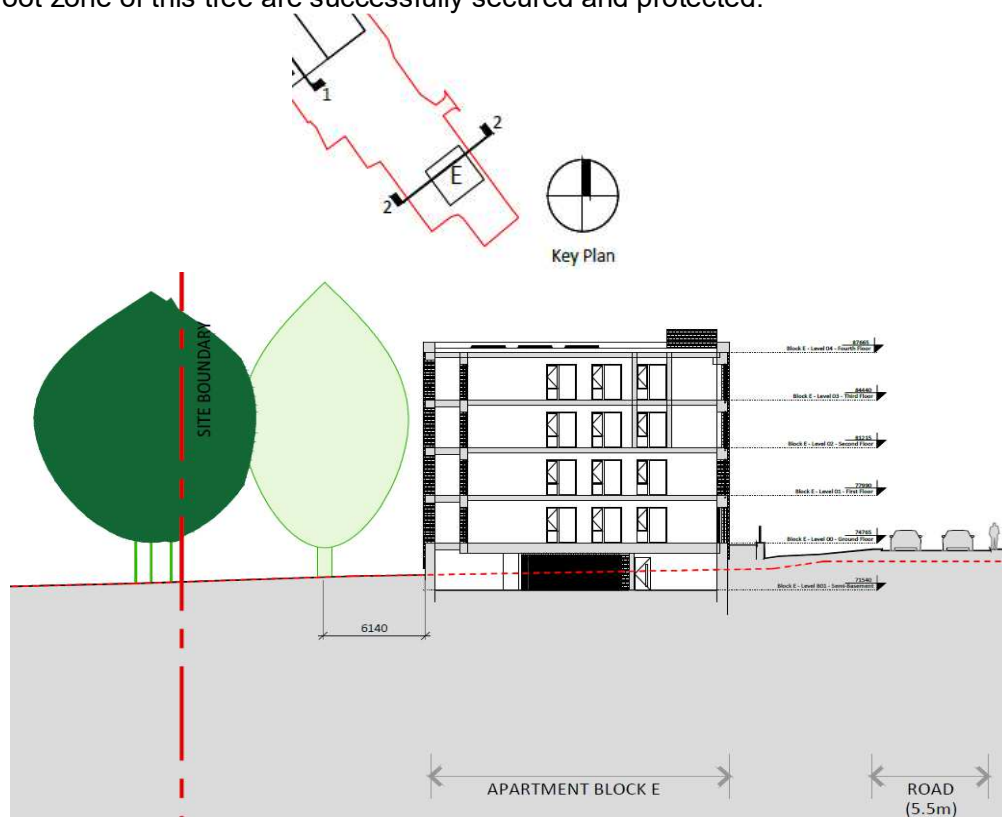
Tree No.0715 is a mature Ash (*Fraxinus excelsior*) which is being retained in close proximity to the proposed apartment block 'E' will have the corner of the basement and building positioned in its calculated root zone on its south-eastern side, but this encroachment is not expected to have a negative impact on this tree's health and its ability to be retained. The excavation for the basement towards the tree is to be kept to its minimum with minimal battering back of the excavated face if roots are encountered and it may also be necessary to look at piling as a means to reduce the extent of the excavation into the root zone of this tree. All works on the basement and the building of Block E will need to work away from this tree and outside its remaining root zone. If any access is required for working on the building façade within the remaining root zone of this tree, then ground protection to the recommendations of 'Section 6 of BS5837 2012' will need to be put in place for the duration of these works and this is to be fit for purpose to protect the underlying ground from damage. The construction process around this tree will need to be discussed with the building contractor pre-commencement to review how the basement will be excavated and built and so that a detailed building method statement can be prepared by the building contractor to ensure that the necessary tree protection measures can be put in place. It will also be important that these works are monitored by the project Arboriculturist during construction to ensure that the root protection area and the root zone of this tree are successfully secured and protected.

Section east to west through the block 'E' prepared by project architects showing the relationship between the building & Tree No.0715 shown in light green

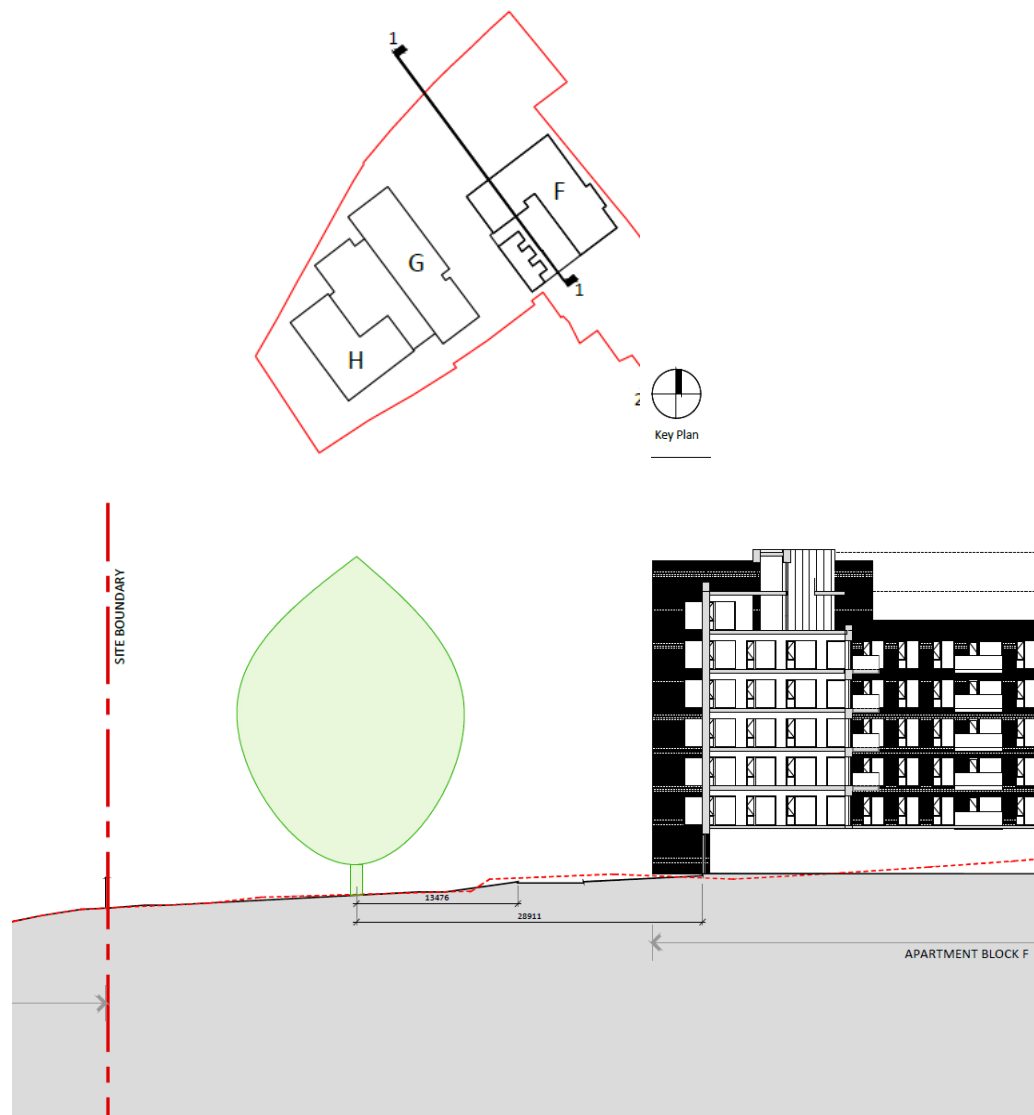
Tree No.0996 is a large mature Monterey Cypress (*Cupressus macrocarpa*) located along the northern side of the site area. This tree is being retained on an open space and all construction works including services have been positioned to be located outside its root zone. Tree protection will need to be erected at the commencement of the works around this tree and be retained in place for the duration of the construction works and the existing ground levels are to be incorporated into the completed landscaped grounds without changes that could result in soil and root damage.

Section running north to south through block 'F' prepared by the project architects showing the finished levels around Tree No.0996.
